NATIONAL BUREAU OF STANDARDS REPORT

INVESTIGATION OF THE DIRECTIONAL EFFECTS IN THE STRESS CORROSION OF ALUMINUM ALLOYS

Final Report

April 22, 1968

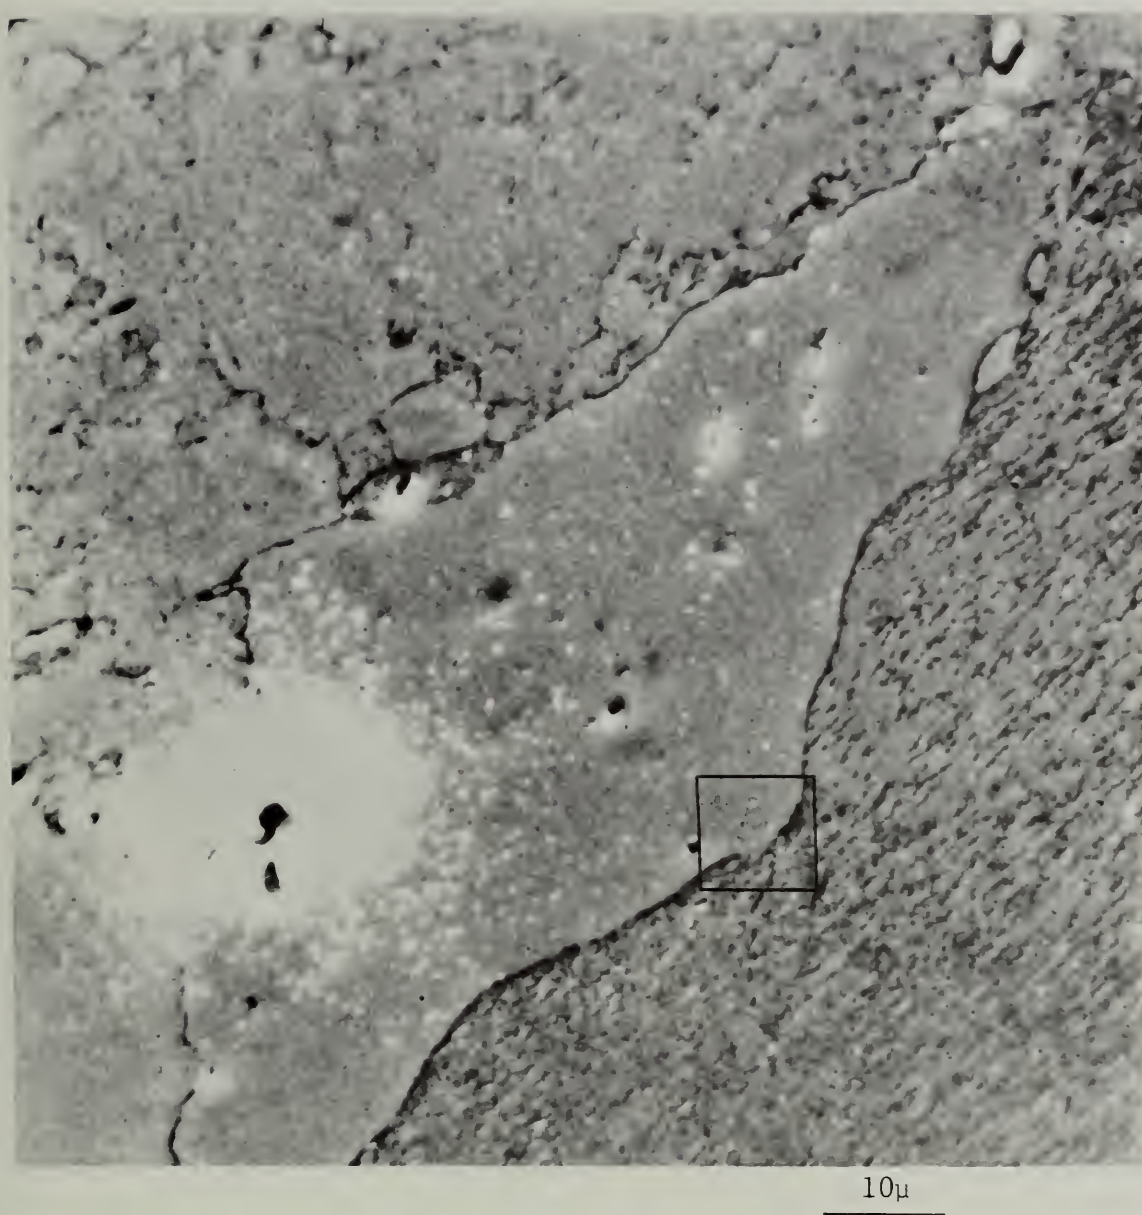
FIGURE 32

Scanning electron micrograph of the surface of an unstressed specimen after 5 minutes exposure to the chromate solution. Note general pitting and intergranular corrosion. See Figure 33 for greater detail of enclosed area. X 1,500

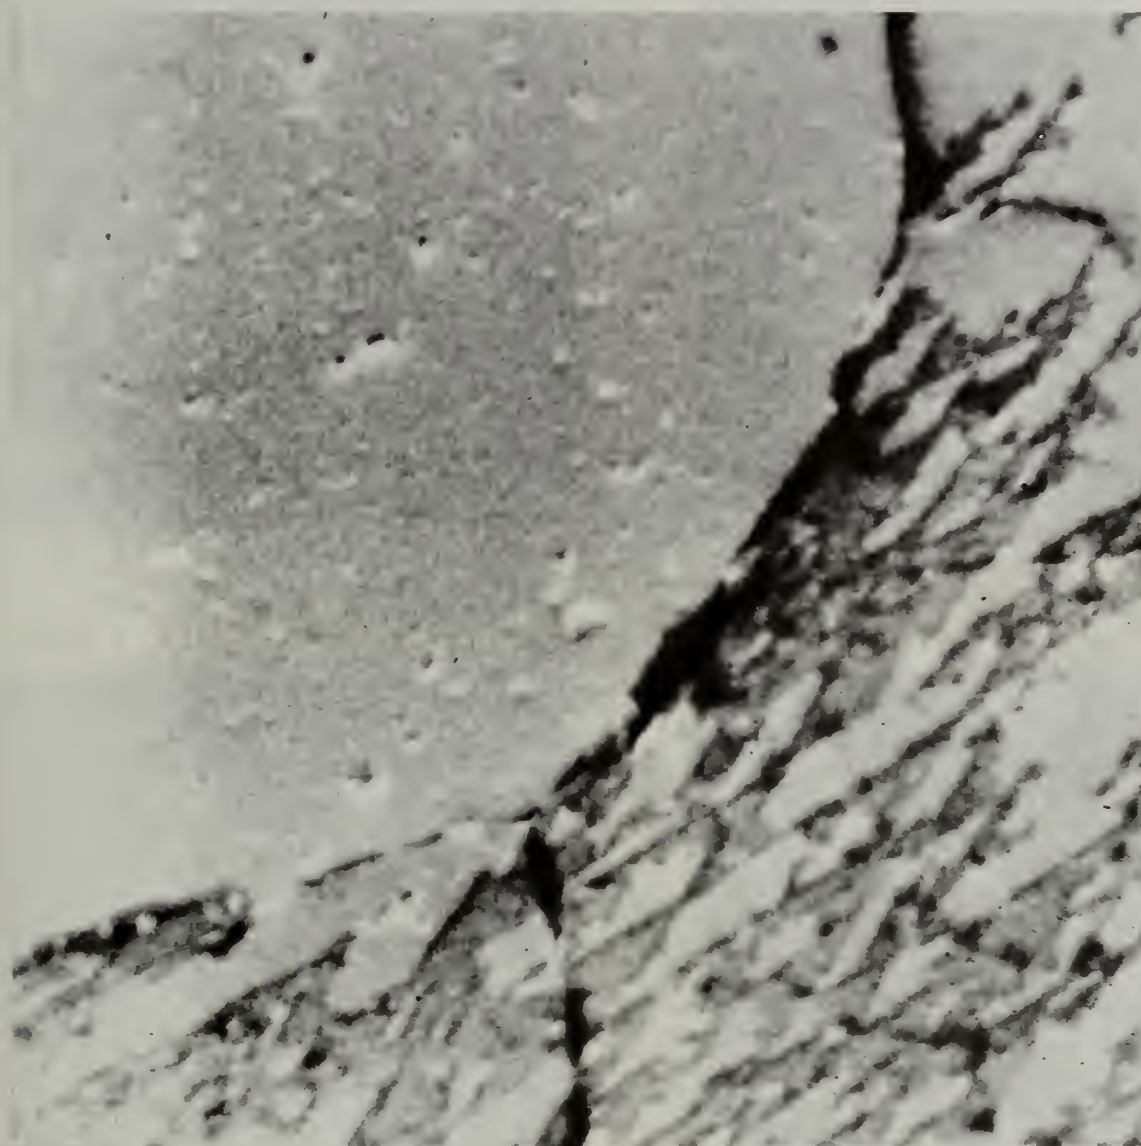
FIGURE 33

Scanning electron micrograph of the area marked off in Figure 32. Note general pitting and intergranular corrosion. X 15,000

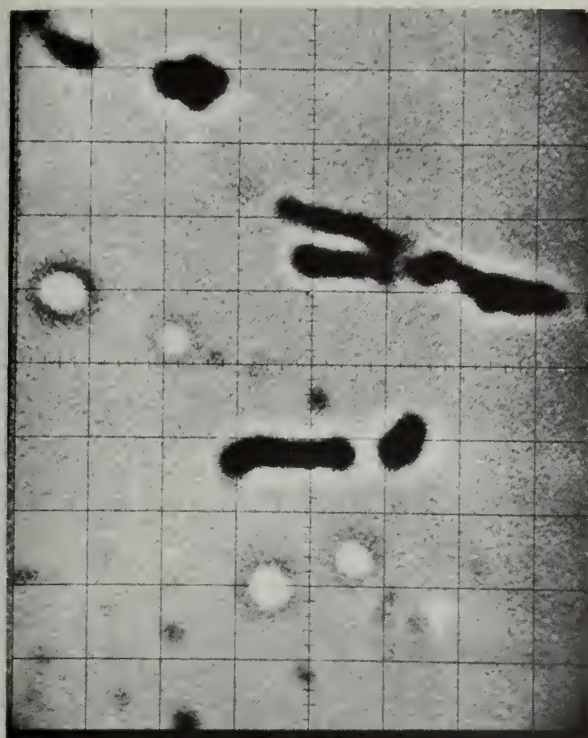
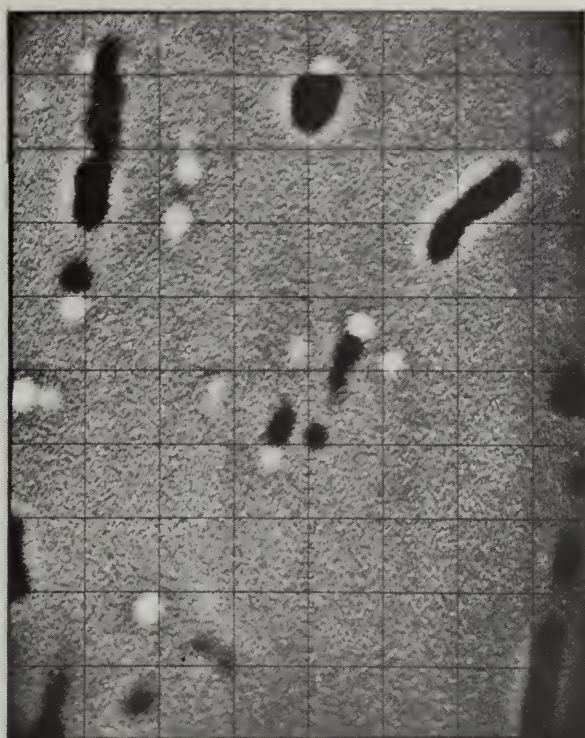
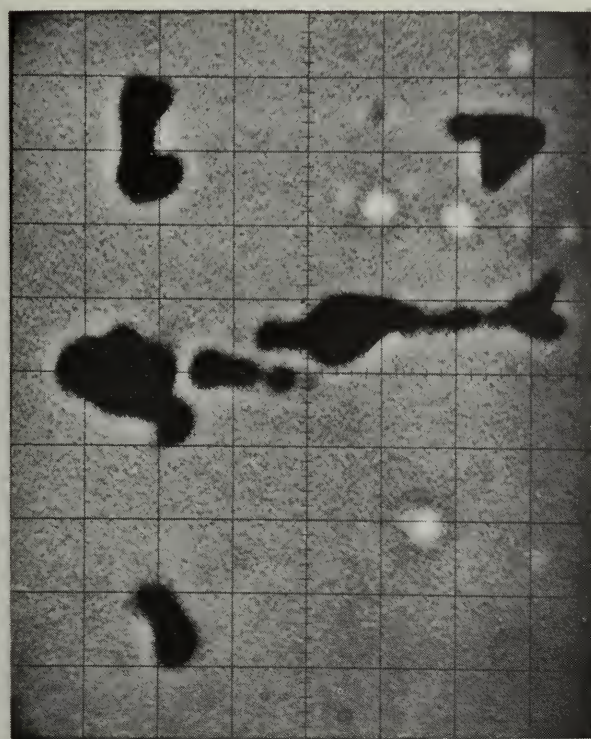
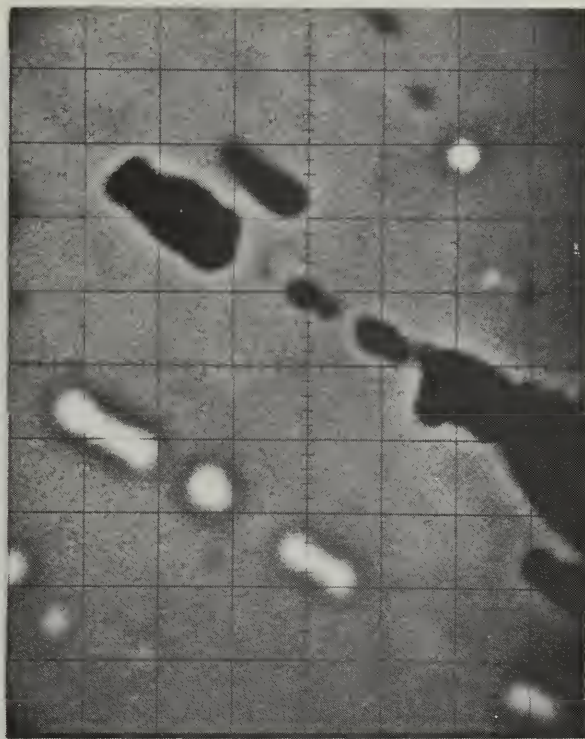
FIGURE 34

Target current images of areas with inclusions from a 7075 aluminum alloy plate. The light areas indicate inclusions of lower atomic number and the dark areas, inclusions of higher atomic number than the matrix. Both the -T651 (a & b) and the -T73 (c & d) treatments are shown. Areas shown include the short transverse-long transverse plane (a & c) and the short-transverse-longitudinal plane (b & d). $7\mu/\text{div}$.

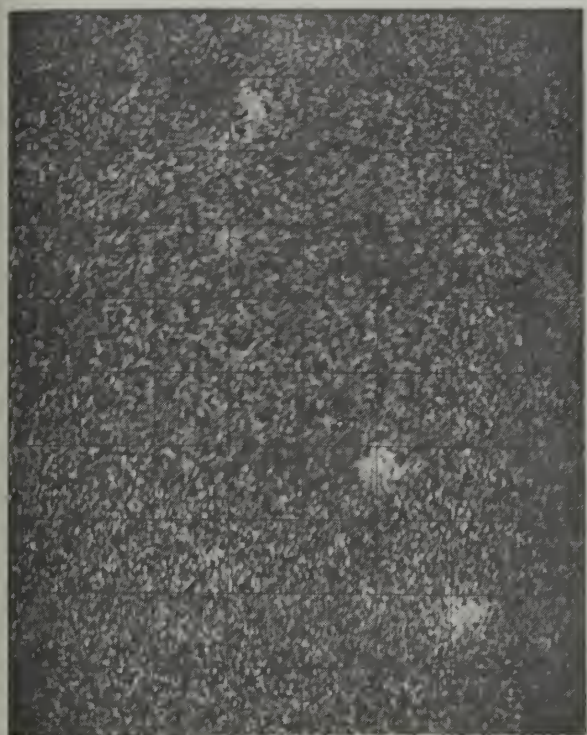
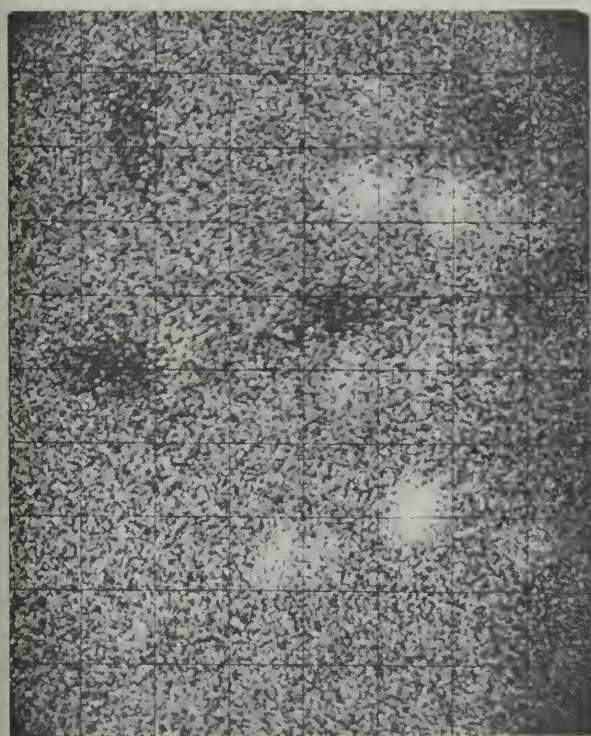
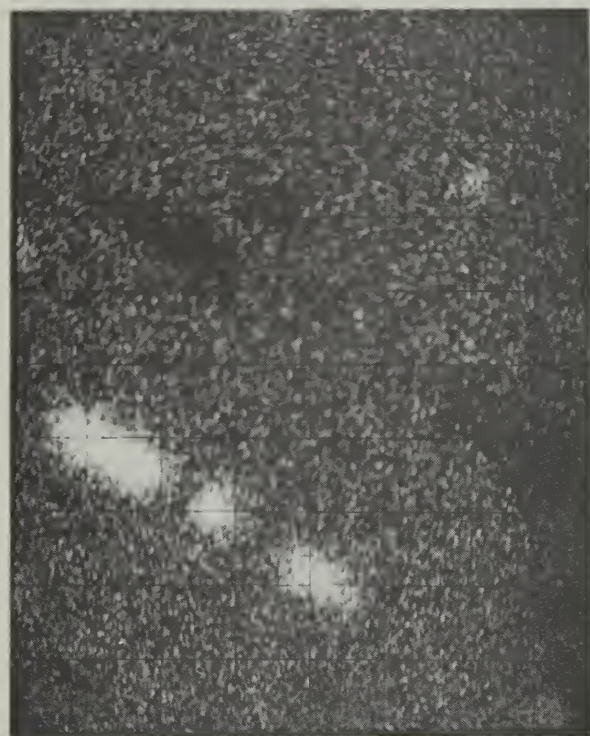
FIGURE 35

Magnesium X-ray images of areas shown in Figure 34. Light areas are high in magnesium.

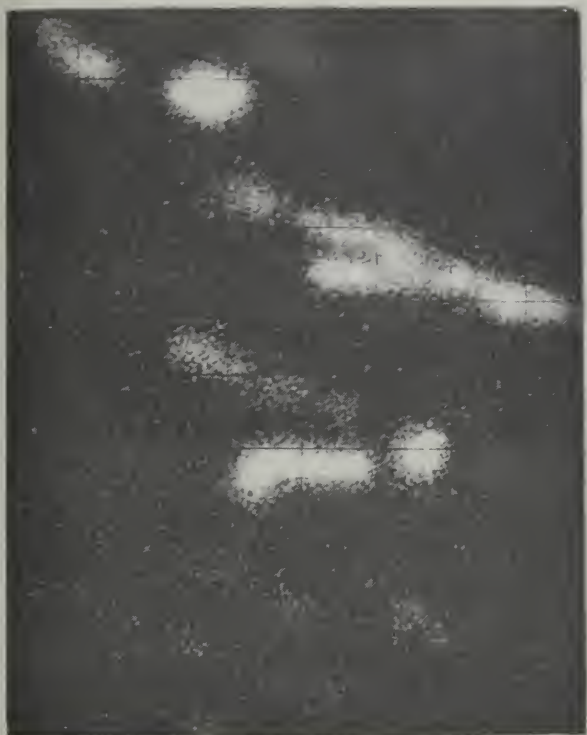
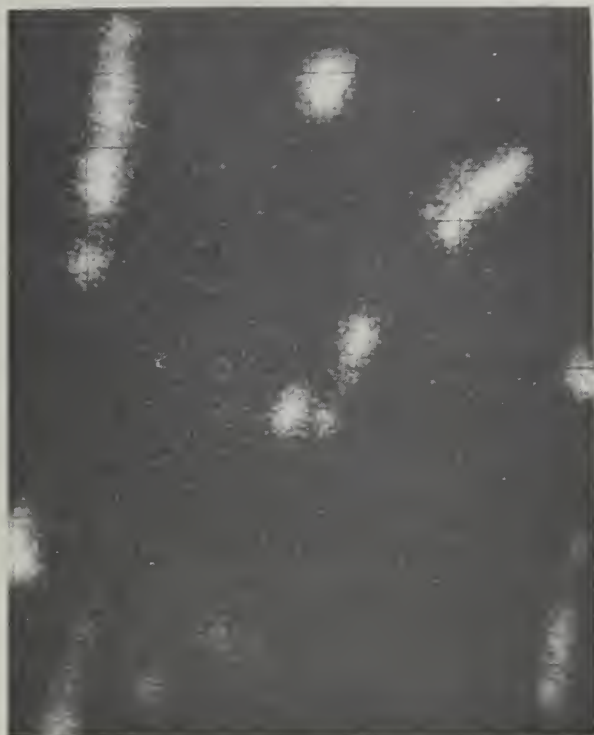
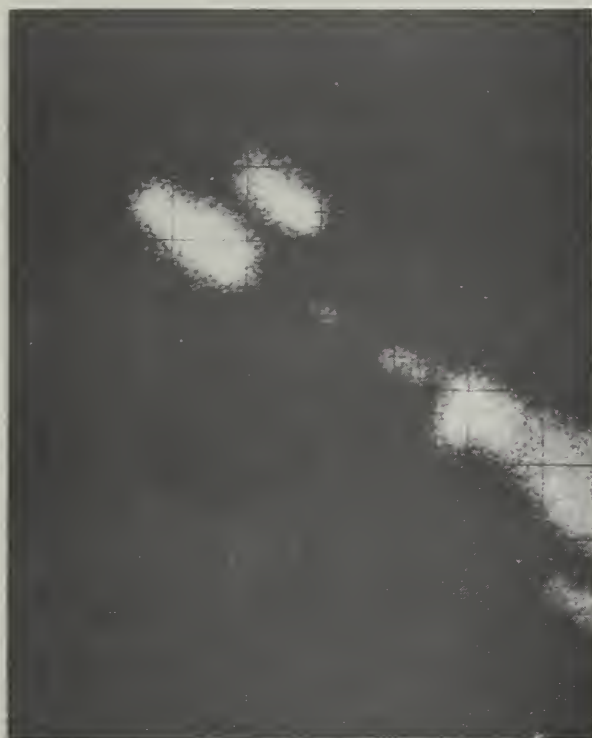
FIGURE 36

Iron X-ray images of areas shown in Figure 34. Light areas are high in iron.

Figure 36, the iron X-ray images, shows iron to be highly segregated at the dark particles of Figure 34. Copper and manganese were also segregated at these inclusions. Aluminum and zinc were found to be depleted at all inclusions.

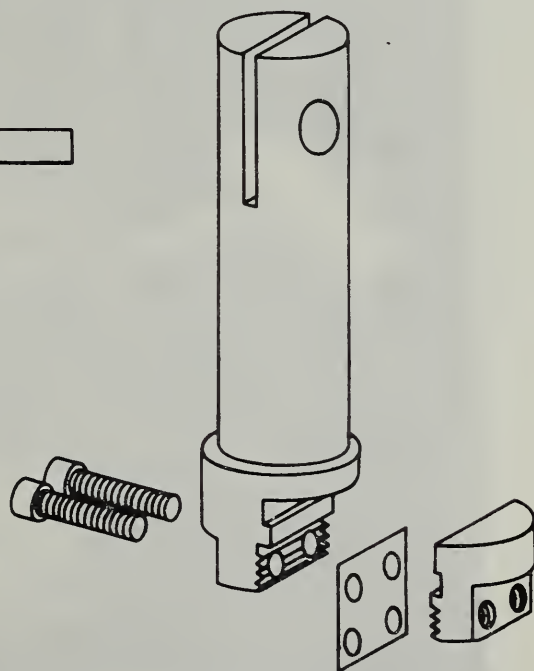
FIGURE 39

Initial electrochemical stress corrosion cell design for externally applied stress on square specimens.

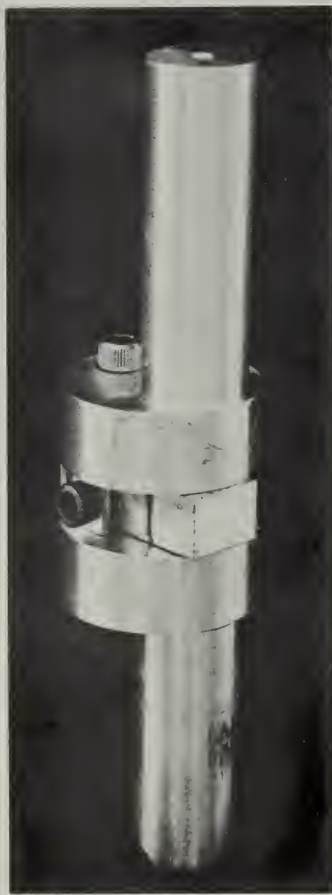
FIGURE 40a

Tuning fork specimen in mounting bracket.

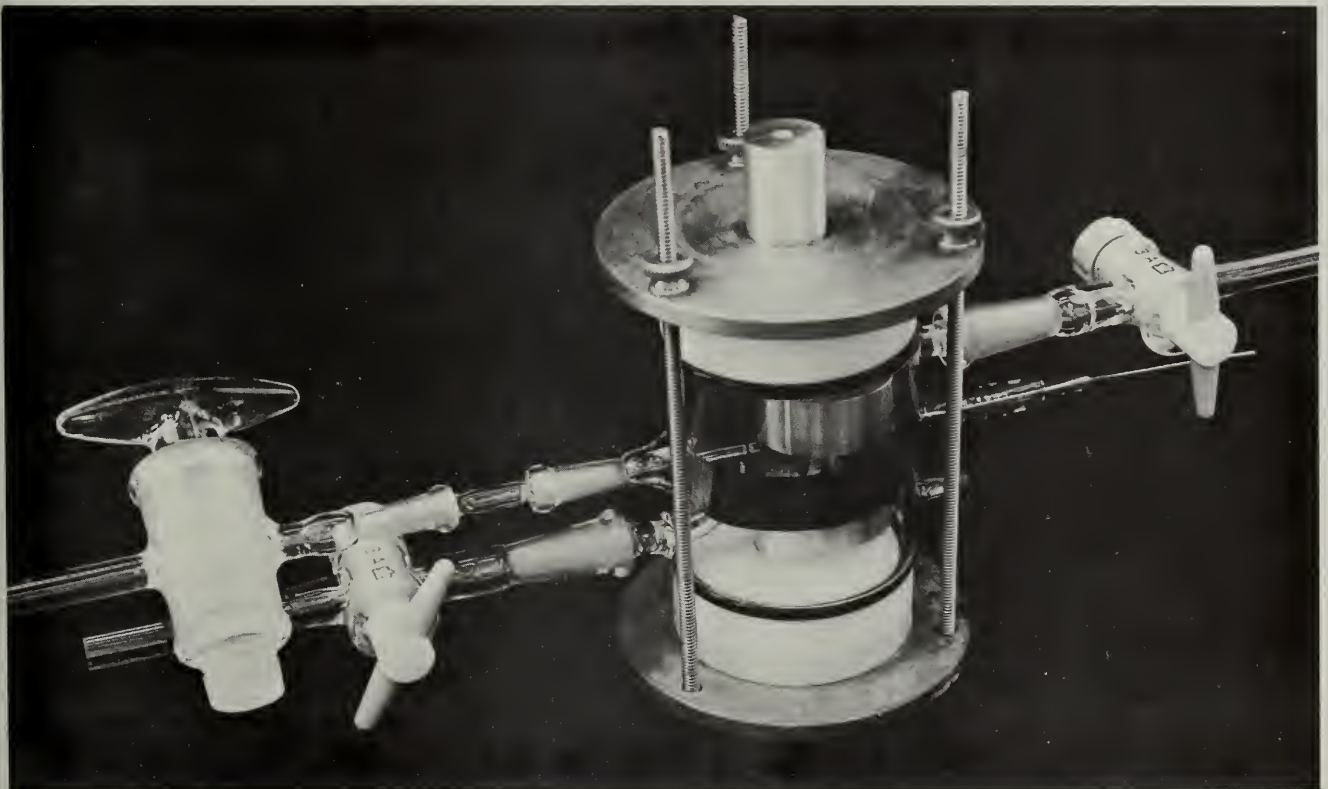
FIGURE 40b

Assembled electrochemical stress corrosion cell for self-stressed tuning fork specimens.

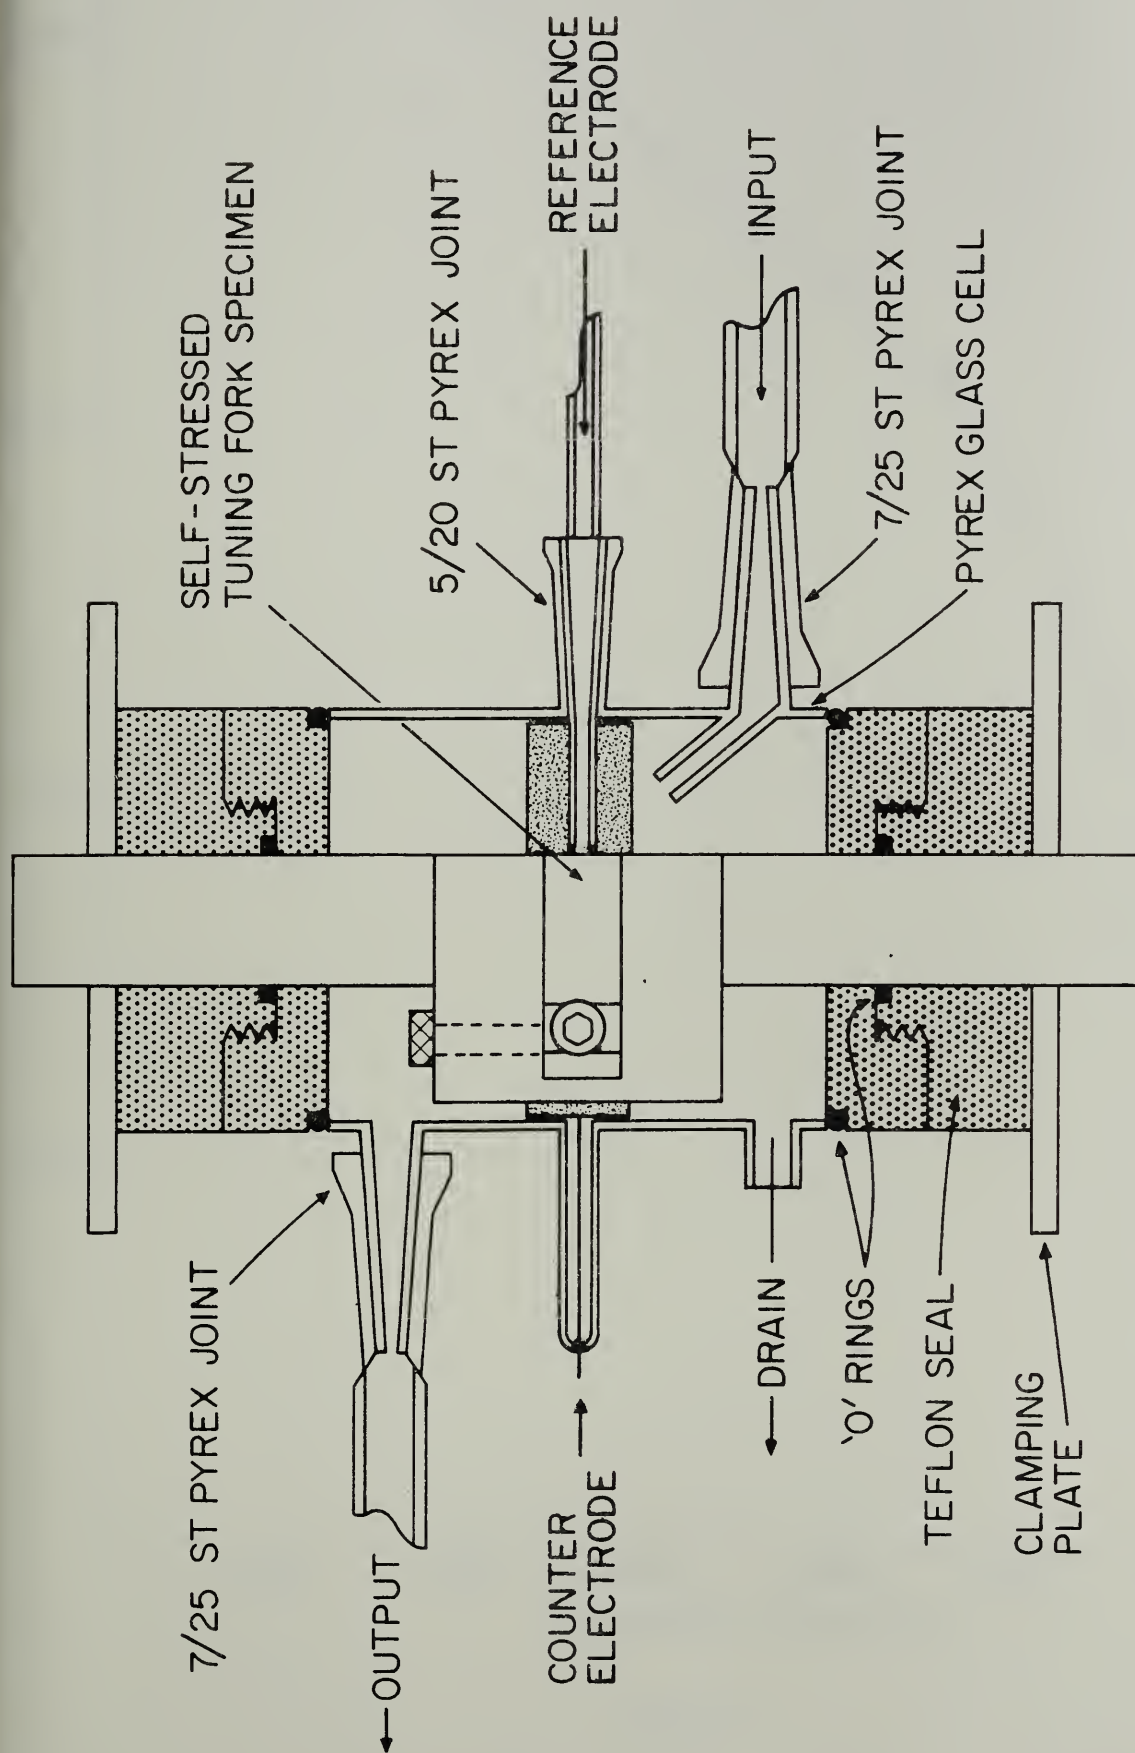
FIGURE 41

Final electrochemical stress corrosion cell design for self-stressed tuning fork specimens.

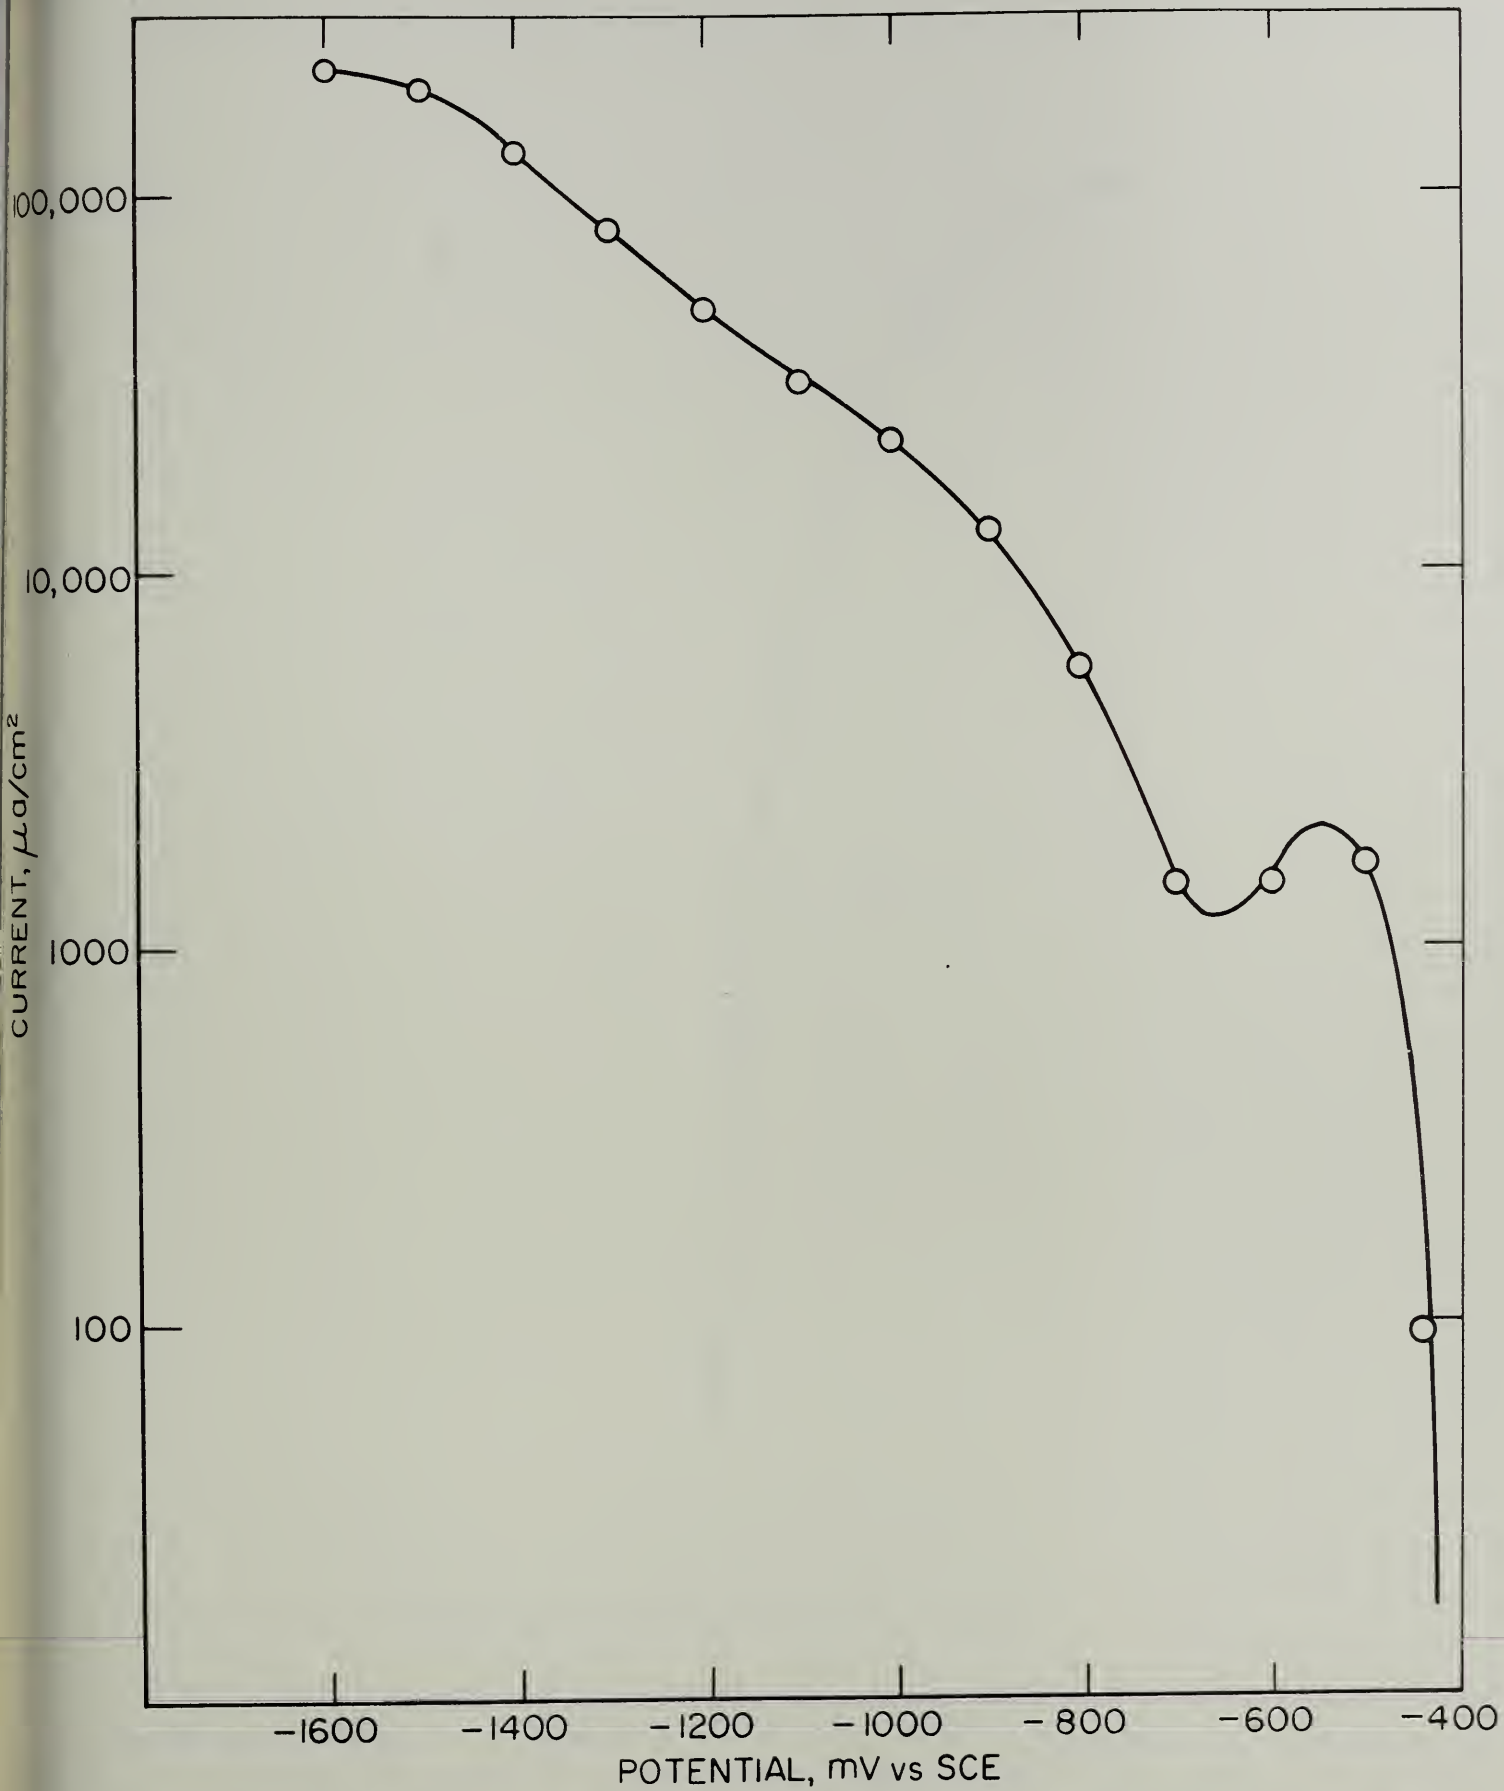
FIGURE 42

Cathodic polarization curve for 7075-T651 in 0.3% NaCl - 3.0% $K_2Cr_2O_7$ - 3.0% CrO_3 . Open circuit EMF = -440 mV vs SCE.

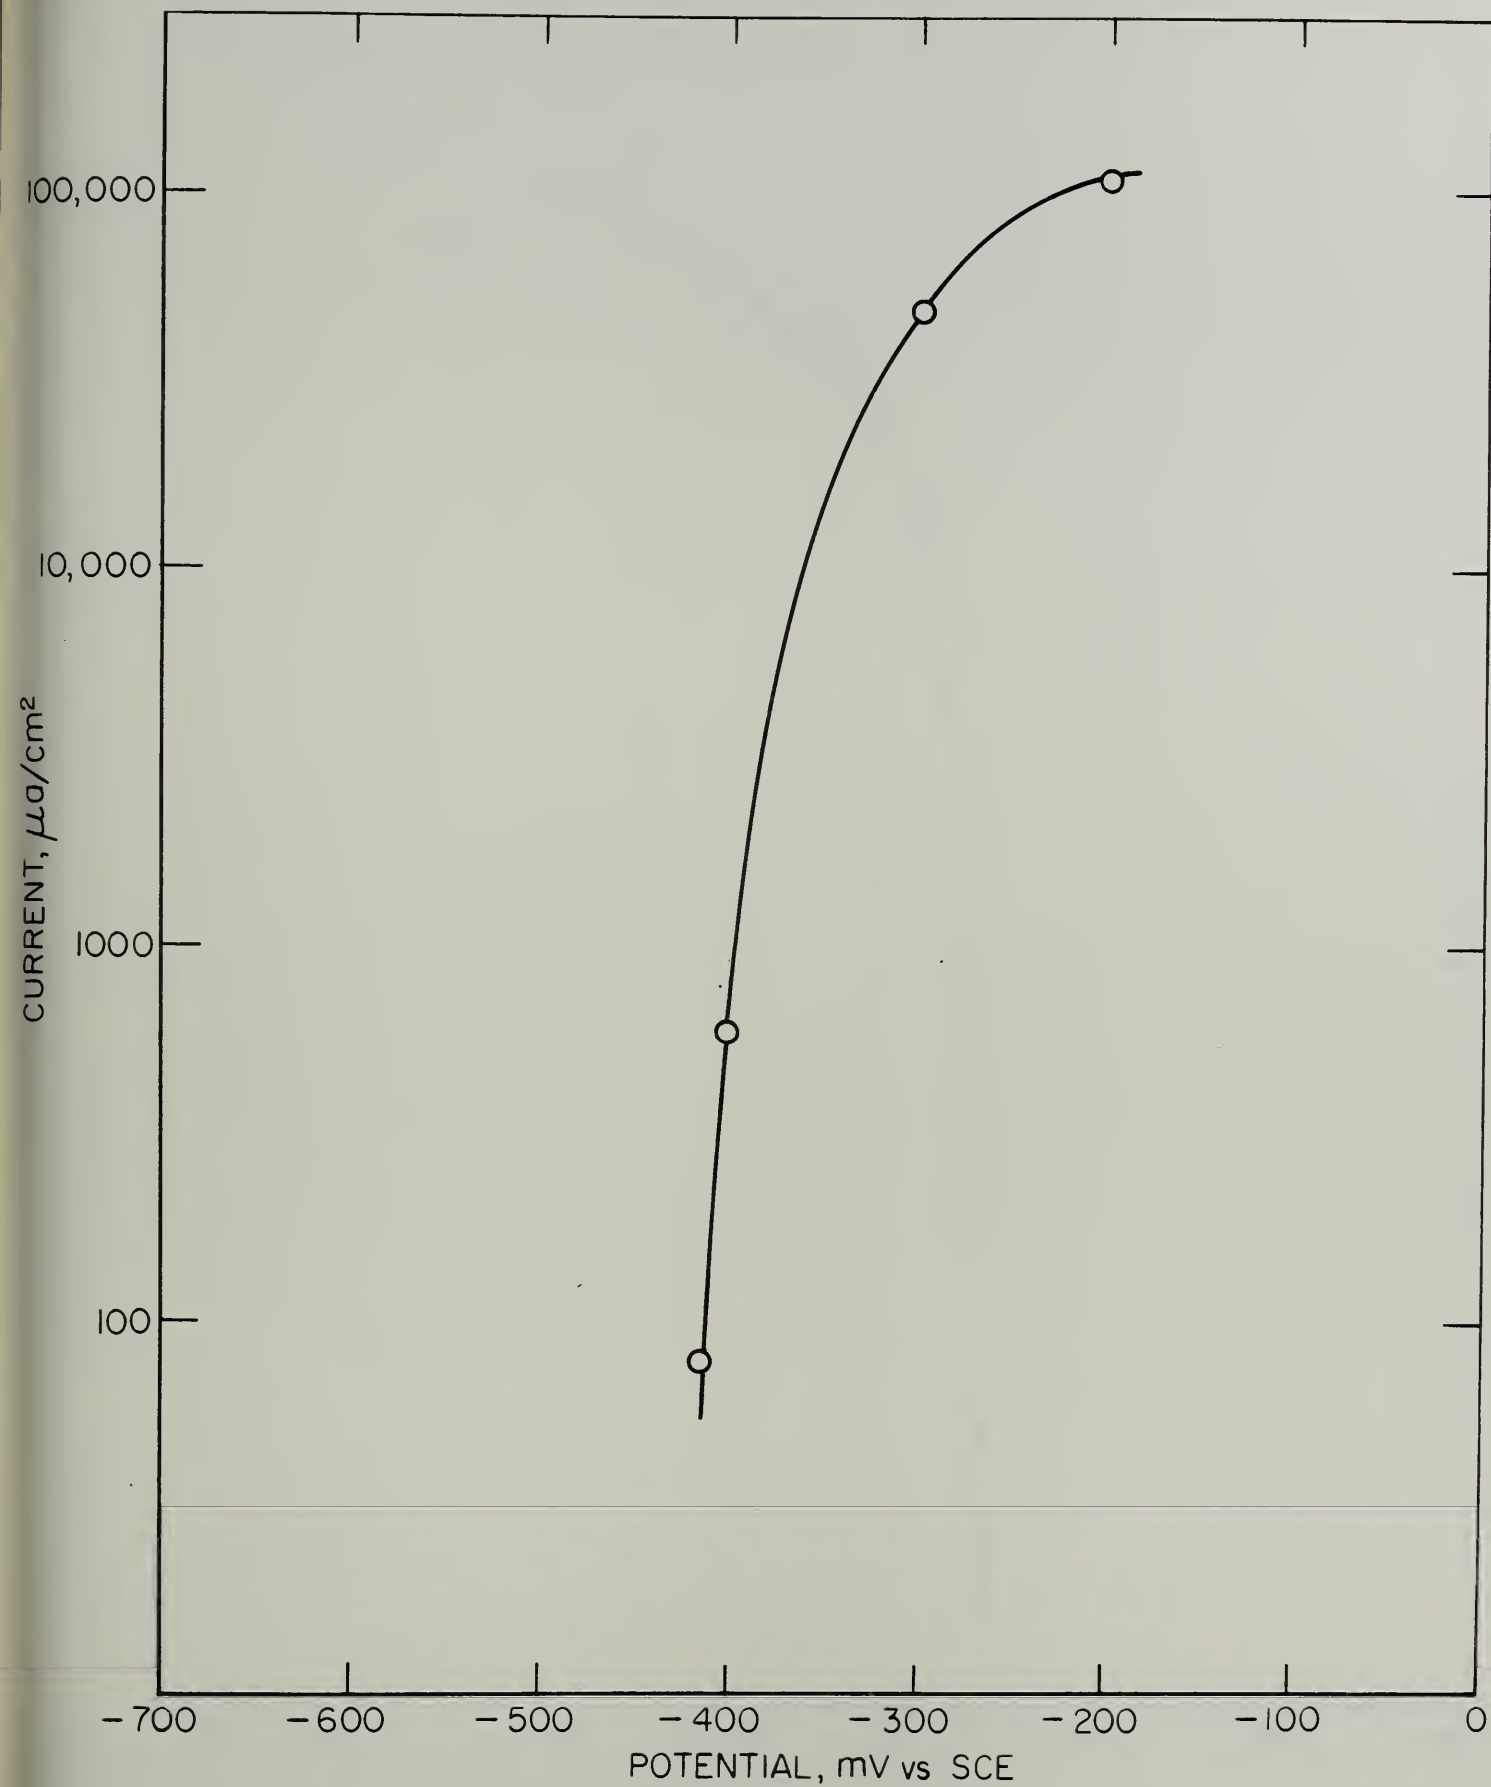
FIGURE 43

Anodic polarization curve for 7075-T651 in 0.3% NaCl -
3.0% $\text{K}_2\text{Cr}_2\text{O}_7$ - 3.0% CrO_3 .

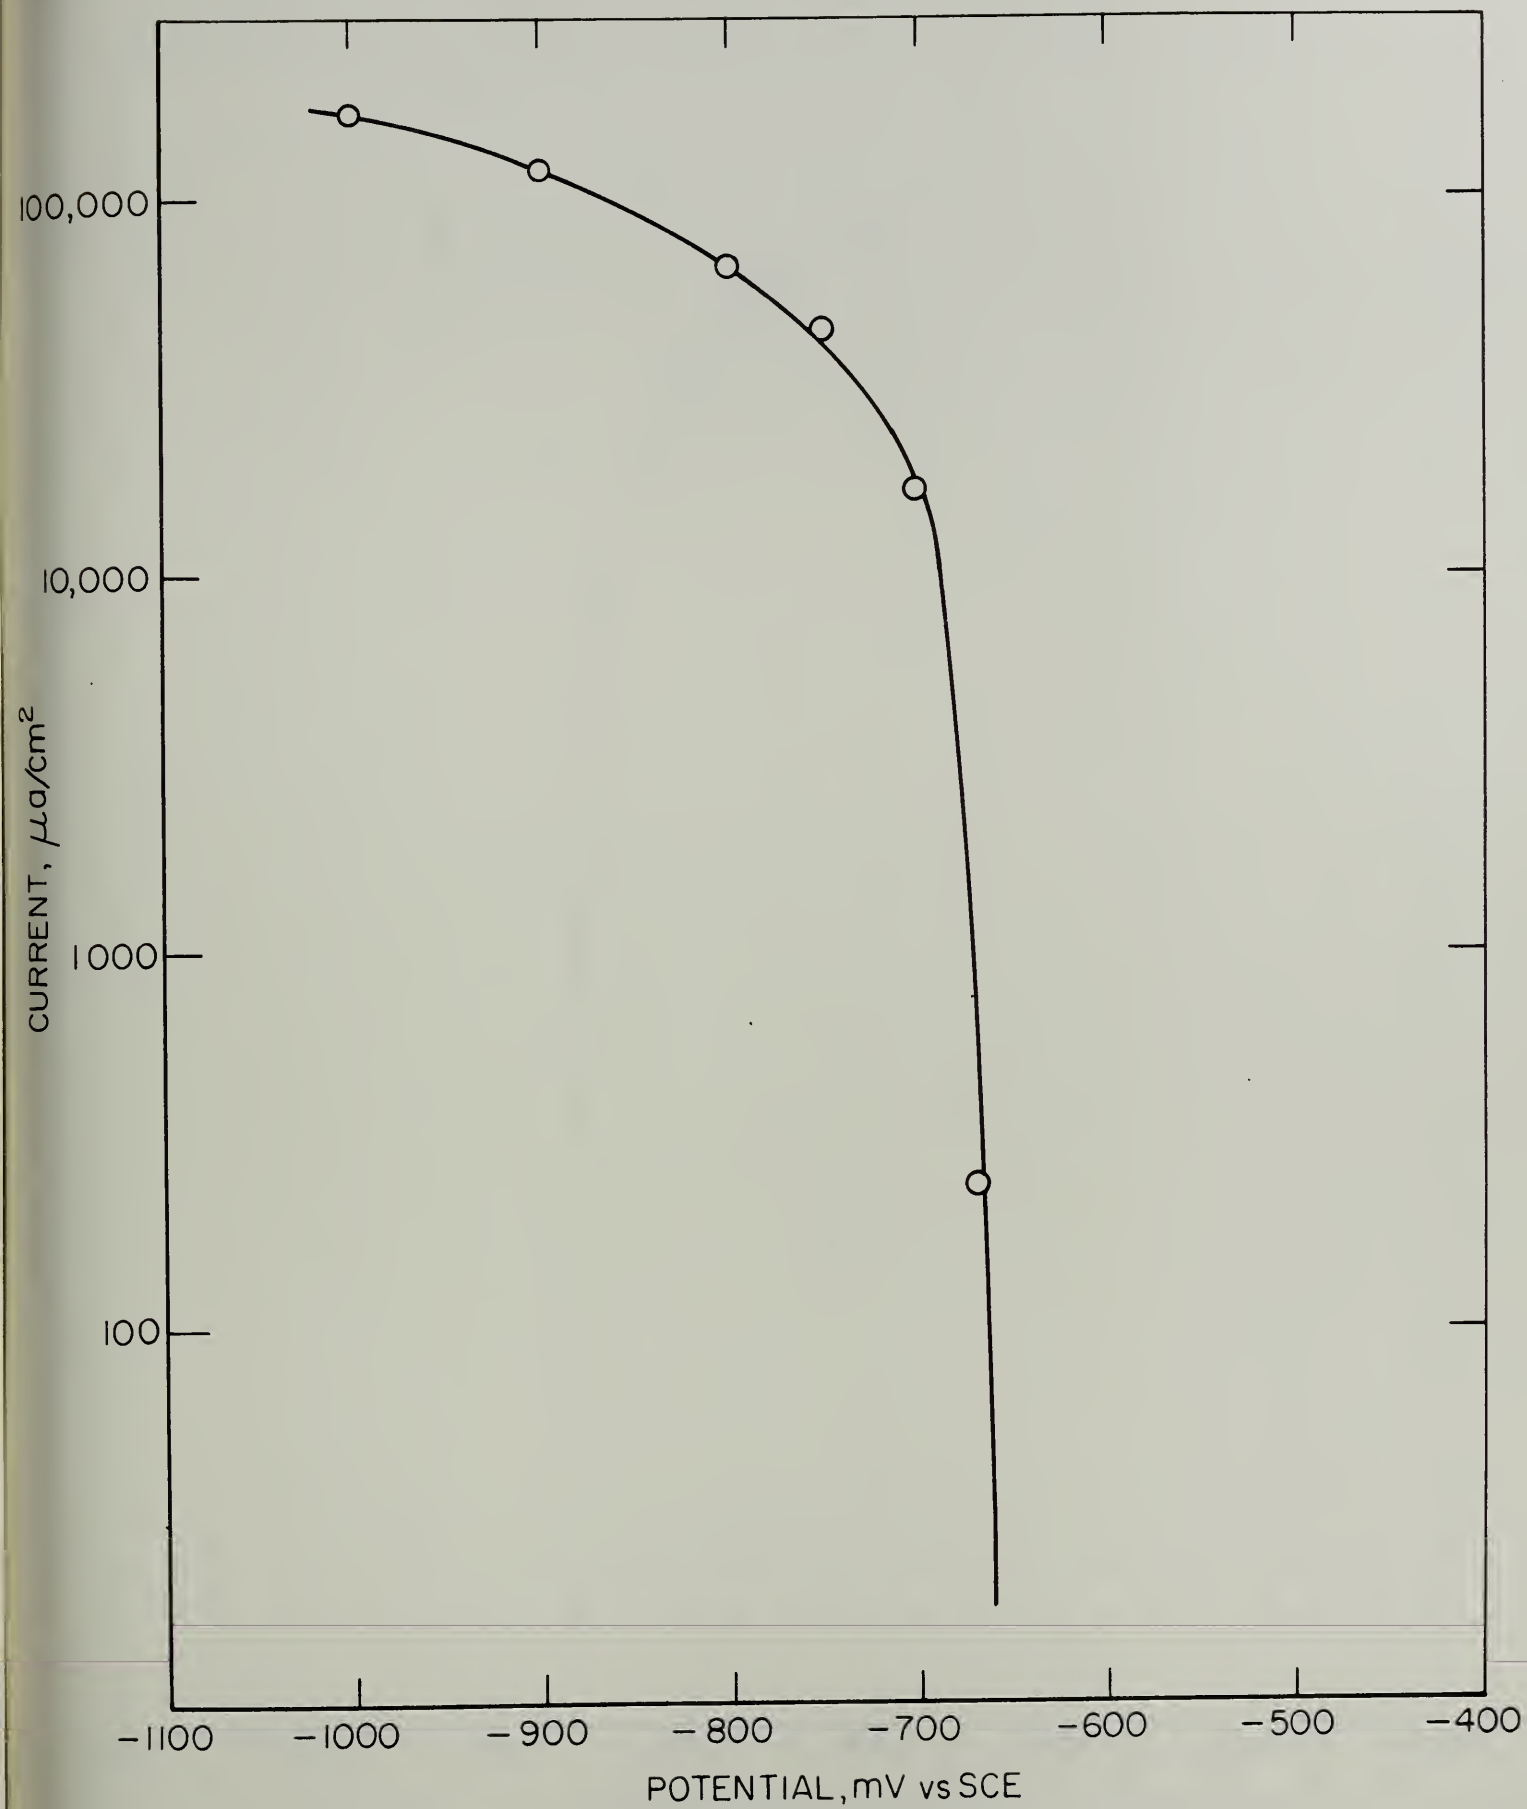
FIGURE 44

Cathodic polarization curve for 7075-T651 in 3.5% NaCl
(pH = 0.9 with HCl). Open circuit EMF = -670 mV vs SCE.

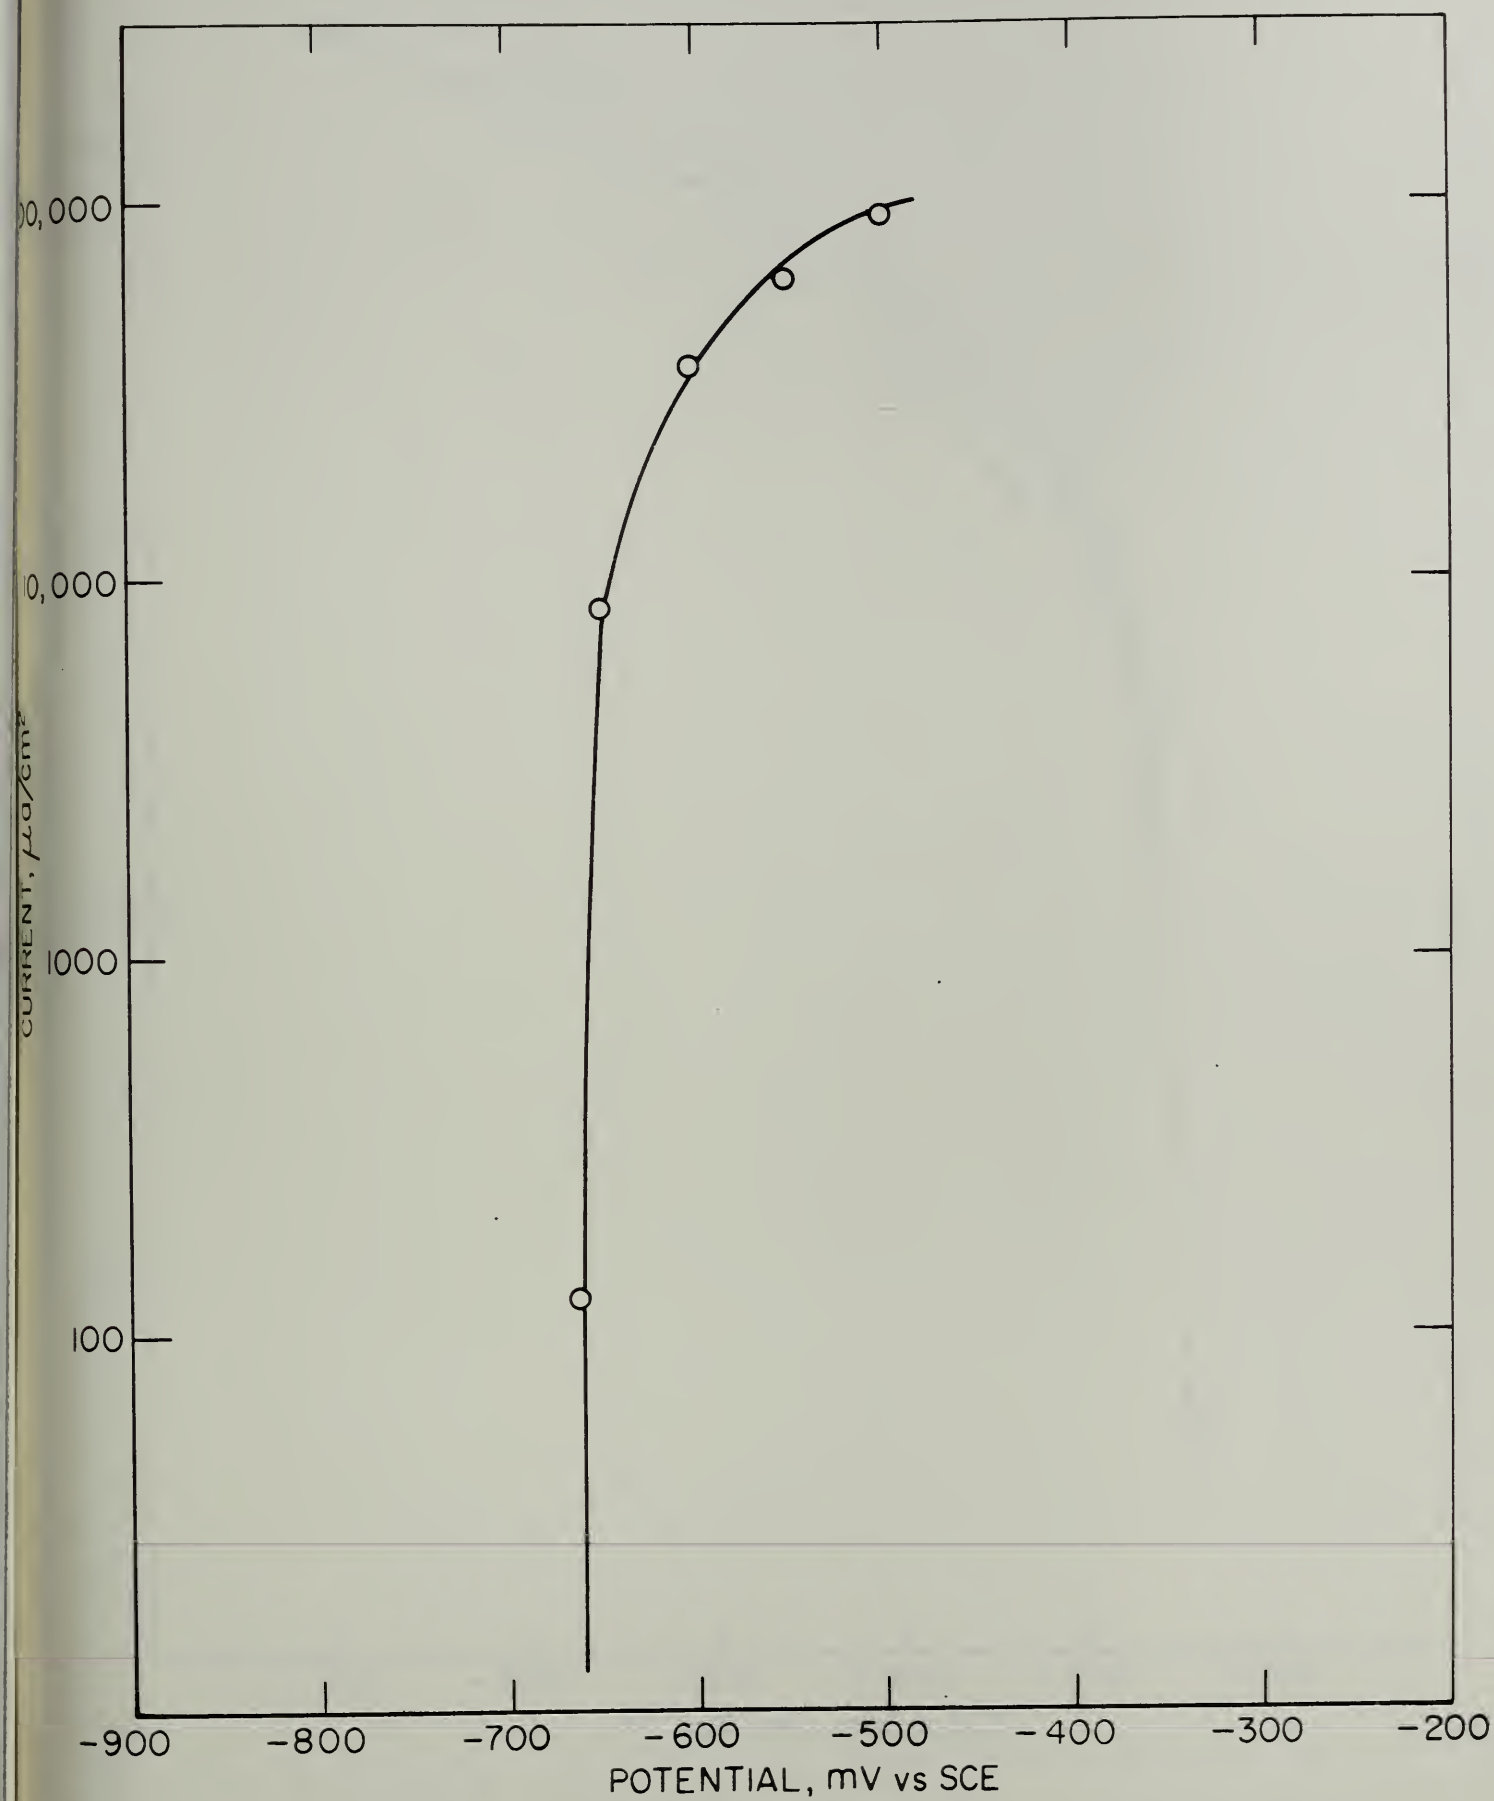
FIGURE 45

Anodic polarization curve for 7075-T651 in 3.5% NaCl
(pH = 0.9 with HCl).
